Commercial Structure
200 N. 1st Street
Dixon, CA

October 26, 2015

Sierra Project No: 20151449-1

Limited Asbestos, Lead, and Fungal Inspection Sampling Report for:
Commercial Structure
200 North 1st Street
Dixon, CA

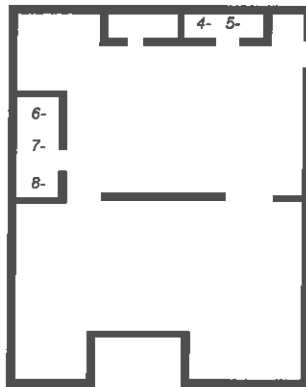
200, 1st Floor

There was a previous water intrusion resulting in fungal growth on the ceiling deck and walls. Visible fungal growth was observed on the center of the floor of unit 260. Unit 200 and the bookstore appeared to be clean and well maintained.

Sample #	Material	Location	% & Type of Asbestos
1-3	TEXTURE	200/BOOKSTORE/BATH	NO ASB DETECTED
4-8	PLASTER	200/1 ST FLOOR	NO ASB DETECTED
9-10	RSF	260/2 ND FL/WATER HEATER RM	NO ASB DETECTED
11-15	PLASTER	260/ 2 ND FLOOR	NO ASB DETECTED
16-20	TEXTURE	260/ 2 ND FLOOR	NO ASB DETECTED

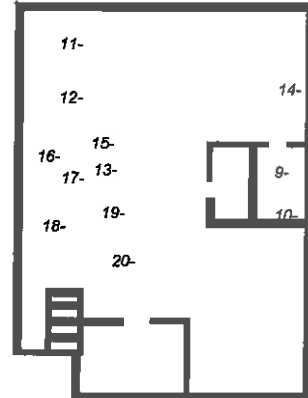
260, 2nd Floor

Bulk sample results indicated presence of *Stachybotrys*, which is an indicator of long-term water intrusion from problems on the ceiling deck of the 2nd floor (Unit 260). See attached laboratory documentation for spore types, levels and sample locations.

3. All damaged porous building materials should be removed 24 inches beyond all signs of water damage or visible fungal growth as follows; **Unit 260:** Scrap the affected plaster from the walls in the bathroom 6-8 feet from the ceiling. Remove and replace ceiling decks from the top of the stairs all the way to the east end of the building and west from top of stairs, as necessary. The remaining structurally sound substrates and framing with excessive fungal growth should undergo decontamination via wire brushing, sanding and HEPA-vacuuming techniques.
