These premises have been inspected by a Certified Access Specialist (CASp).

Inspection Date: 5/23/2012 CASp Signature:

The Public Accommodation areas of this complex have received a CASP Inspection on May 23, 2012 and has received the "CASp Determination Pending" status. The management is maintaining a list of barriers who's removal is considered readily achievable as defined in ADA 36.104 and has a schedule for the removal of those barriers

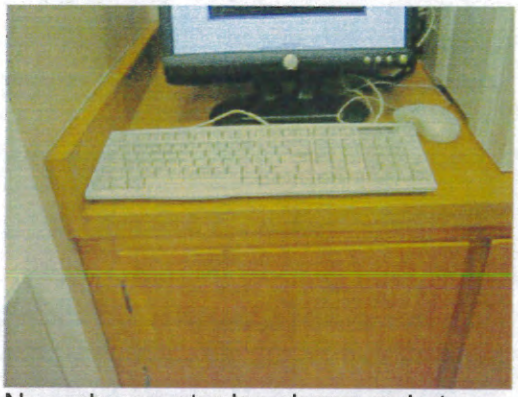
No under counter leg clearance but parallel approach compliant

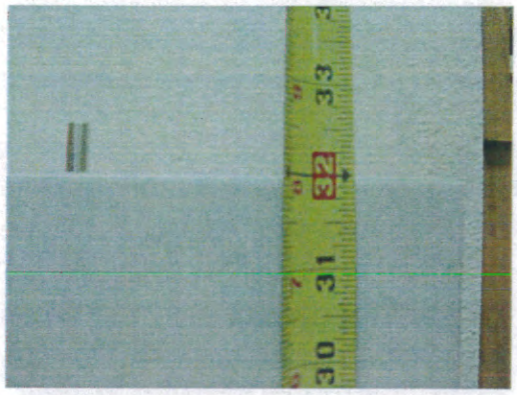
Pay station compliant for reach heights

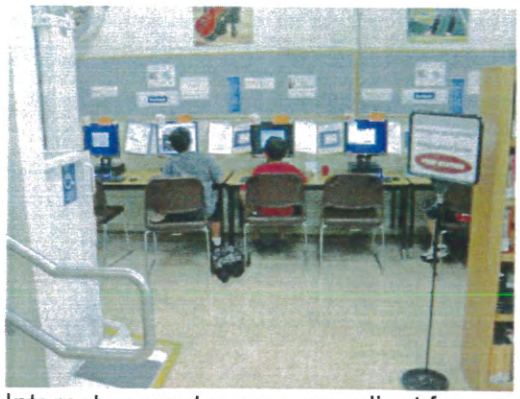
Internet computer area compliant for path of travel access and turning radius

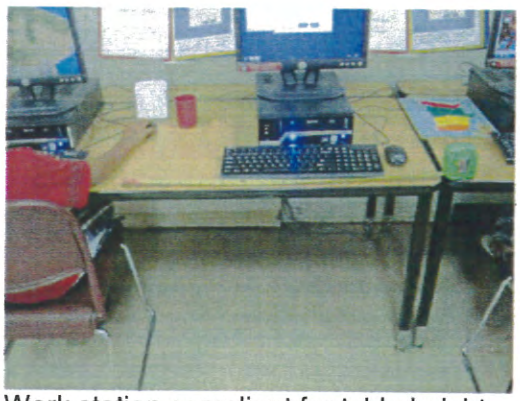
Work station compliant for table height, leg clearance and clear width of station. Not all stations have access clearance. Recommend identifying this station with ISA sign

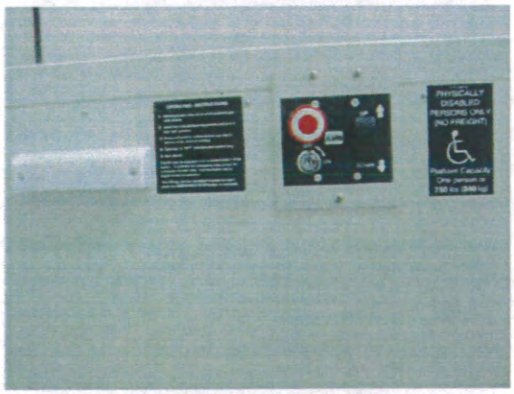
Disabled access lift for upper level.
Compliant for access path, size, operation and controls

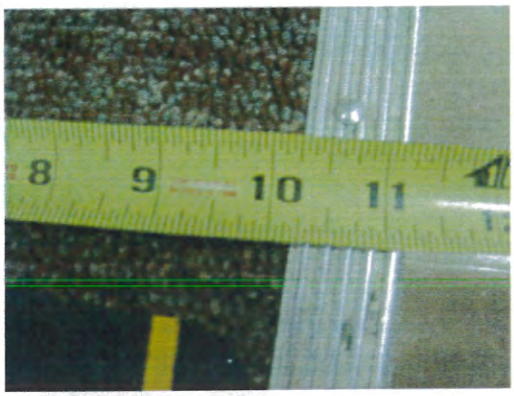
Upper level lift gate

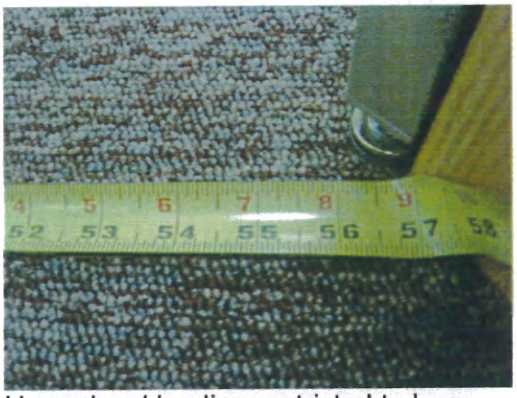
Upper level landing restricted to less than 60" with movable partition

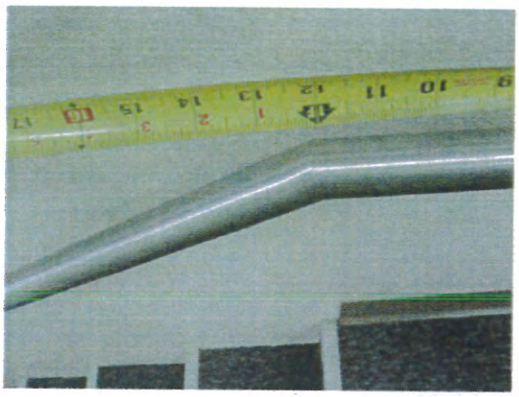
Handrail extension of a protruding object. Needs connecting down to floor

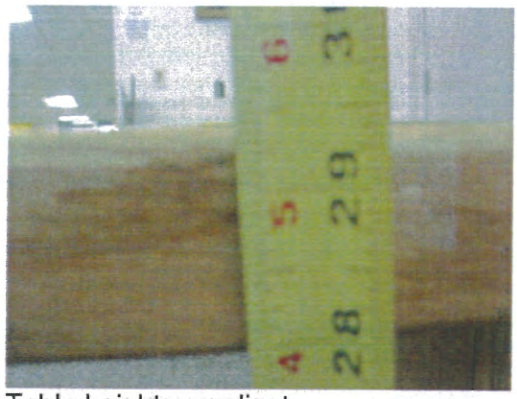
Table height compliant

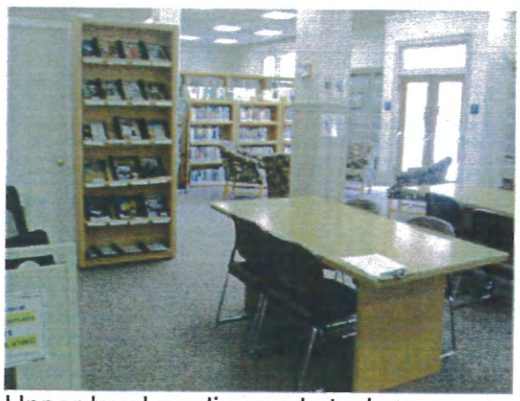
Upper level reading and stack area. Aisle widths compliant, seating compliant

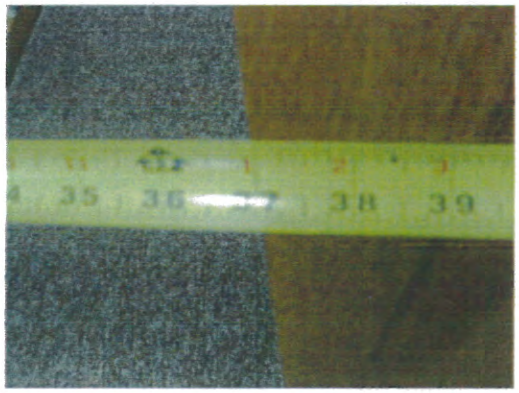
End aisle with typewriter table restricted to less than 36" at table. Relocate table to another location

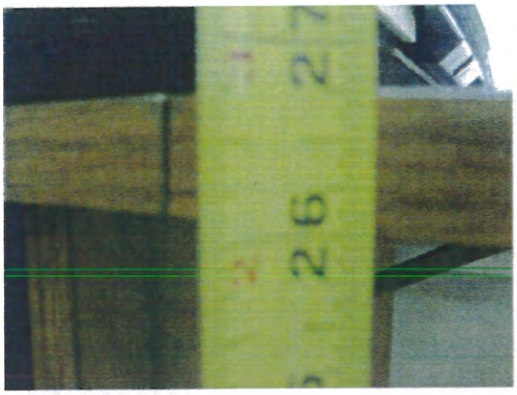
Table width clearance not compliant at less than 30". Replace with compliant table

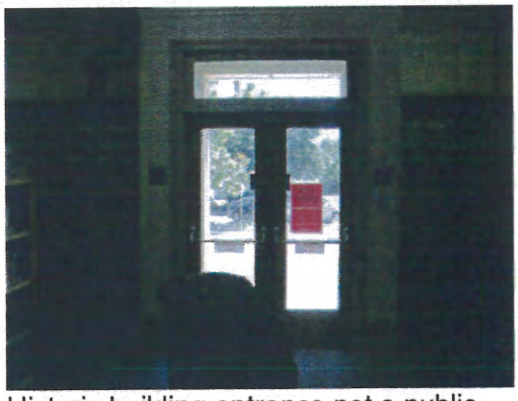
Historic building entrance not a public path of travel for entry or exiting

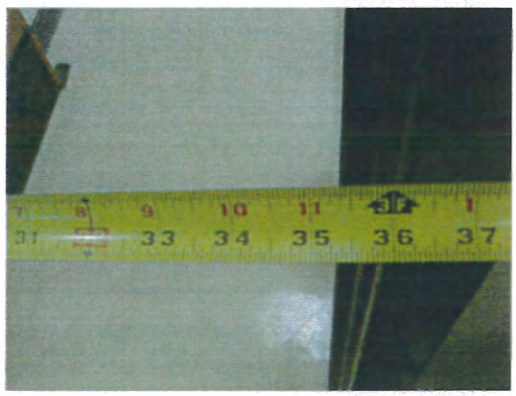
Path of access and signage to disabled compliant toilet room compliant. Door is always open but size and hardware is compliant

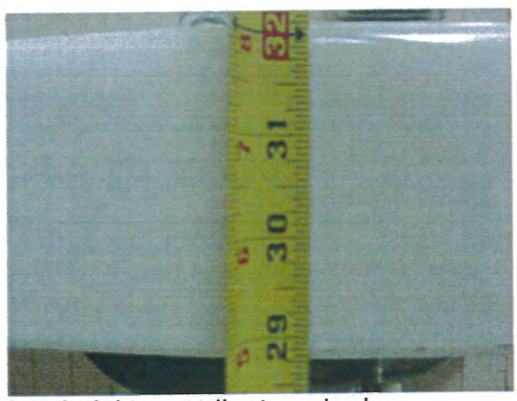
Lav height compliant, under lav clearance short by ¼"

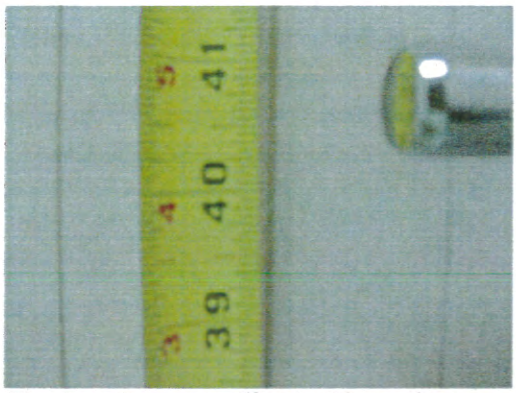
Flush valve compliant at less than 44" aff.

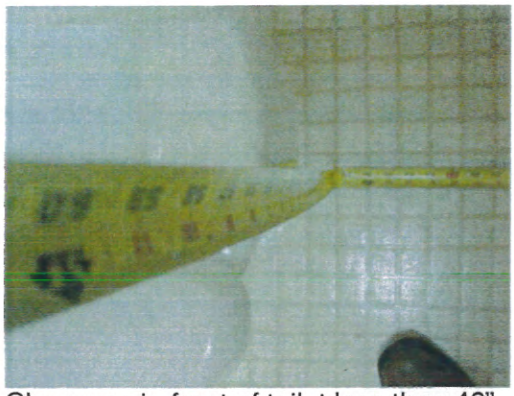
Clearance in front of toilet less than 48". Restricted at one corner of the 30" x 48" access by 10"

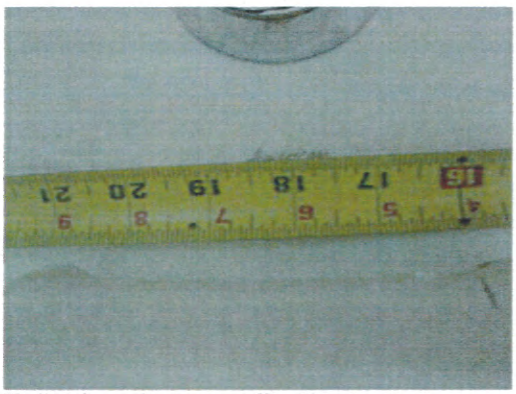
Toilet location compliant

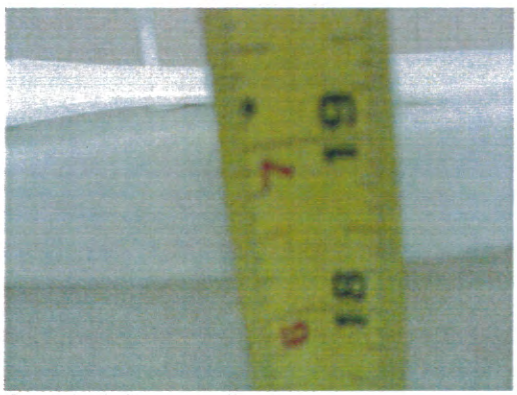
Seat height compliant

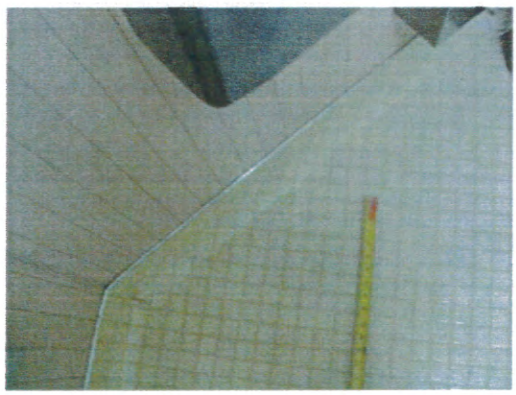
Side bar length compliant

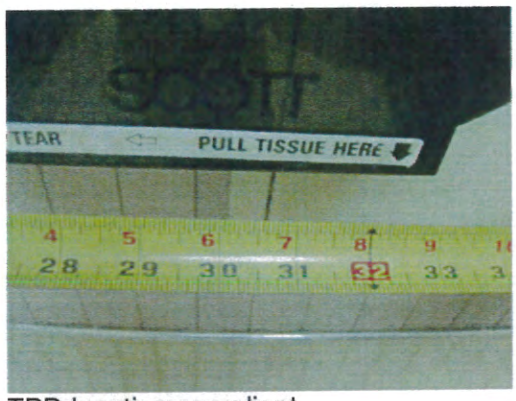
TPD location compliant

End of bar to be at 54"

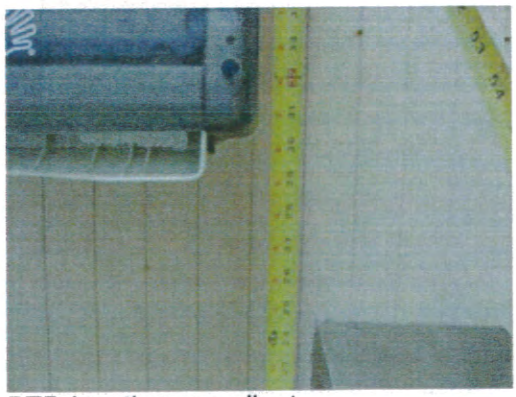
PTD location compliant

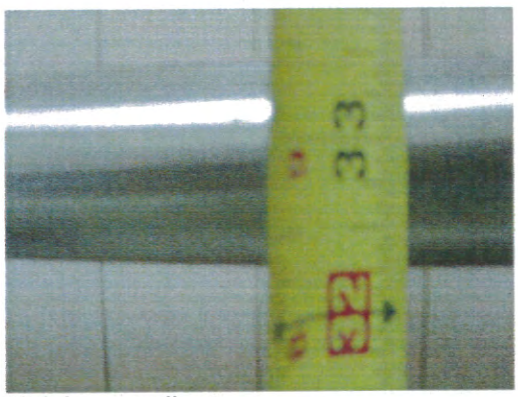
Height compliant

Interior clearances compliant

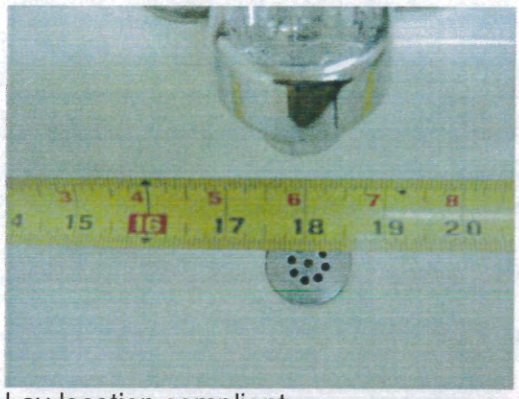
Lav location compliant

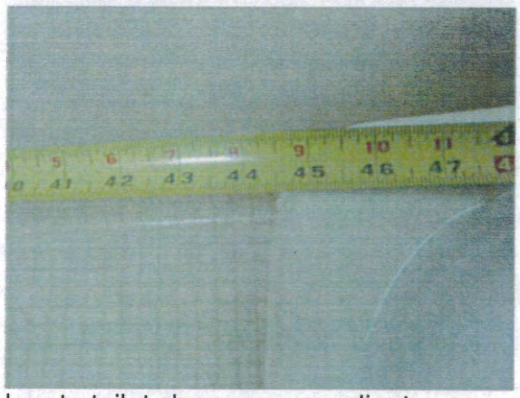
Lav to toilet clearance compliant
